**Response in respect to Regulation 28 report to prevent future deaths -
Investigation into the death of Mr Marcus Szigetvari.**

Background

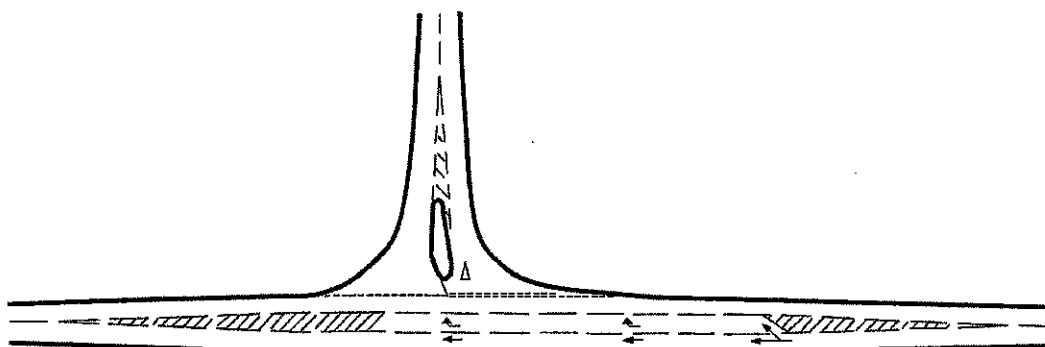
Figure 1 / 2 : Ghost Island Junction (para 1.15)

DMRB sets out the various types of priority junction that may be used and the factors that must be considered in order to determine the correct layout for the location. Whilst there are a wide range of factors that must be considered, a key consideration is major and minor arm traffic flow (traffic using the junction). Having taken account of these factors a Ghost Island Priority Junction was considered appropriate for this

location. The general arrangement of a Ghost Island can be seen below in figure 1 / 2 which is an extract from DMRB and is consistent with the road layout currently in situ which is also shown below in the aerial photograph.

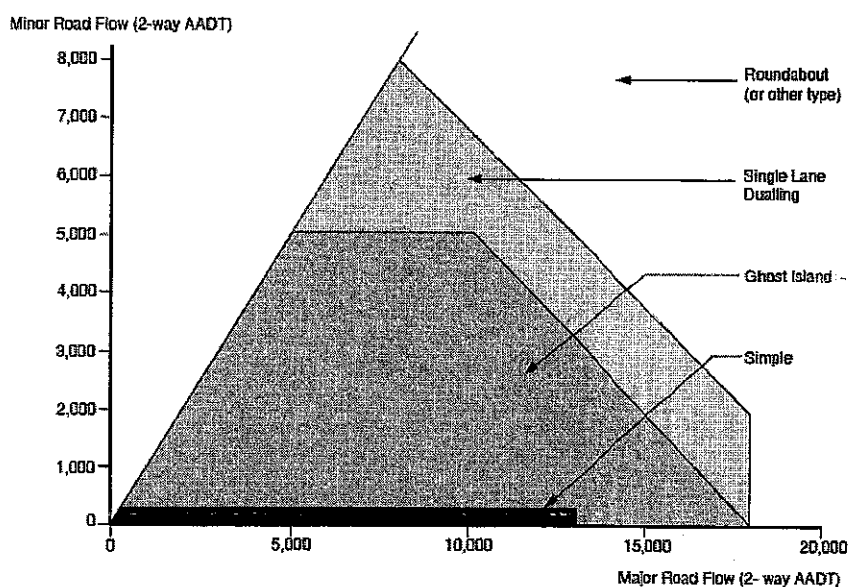
Figure 2/2 : Approximate Level of Provision of T-junctions on New Single Carriageway Roads for Various Major and Minor Road Design Year Traffic Flows (paras 2.2, 2.14)

Figure 2/2 below, again an extract from the DMRB gives an indication why a Ghost Island junction is considered appropriate at this location. For example, whilst design year traffic flows (estimated from traffic models) would have been used to determine the correct junction layout to be used during the design process, recent traffic counts taken at this junction can be fed into the graph in fig. 2 /2 to assess the continued appropriateness of this junction arrangement.

With two way Annual Average Daily Traffic (AADT) flows of 8092 vehicles on the A4233 ('Major Road Flow') and two way Annual Average Traffic Flows of 2275 vehicles on Llanwono Road ('Minor Road Flow'), when plotted on the graph the point of intercept (*) clearly indicates that the use of a Ghost Island Priority junction is the most appropriate junction type for this location given its level of usage.
