Regulation 28 Report: William Steven Israel (ref: ██████████)

- 1 I write in response to your Regulation 28 report dated 3 December 2020 regarding the death of William Steven Israel on railway tracks at Canterbury East railway station on 15 March 2020.

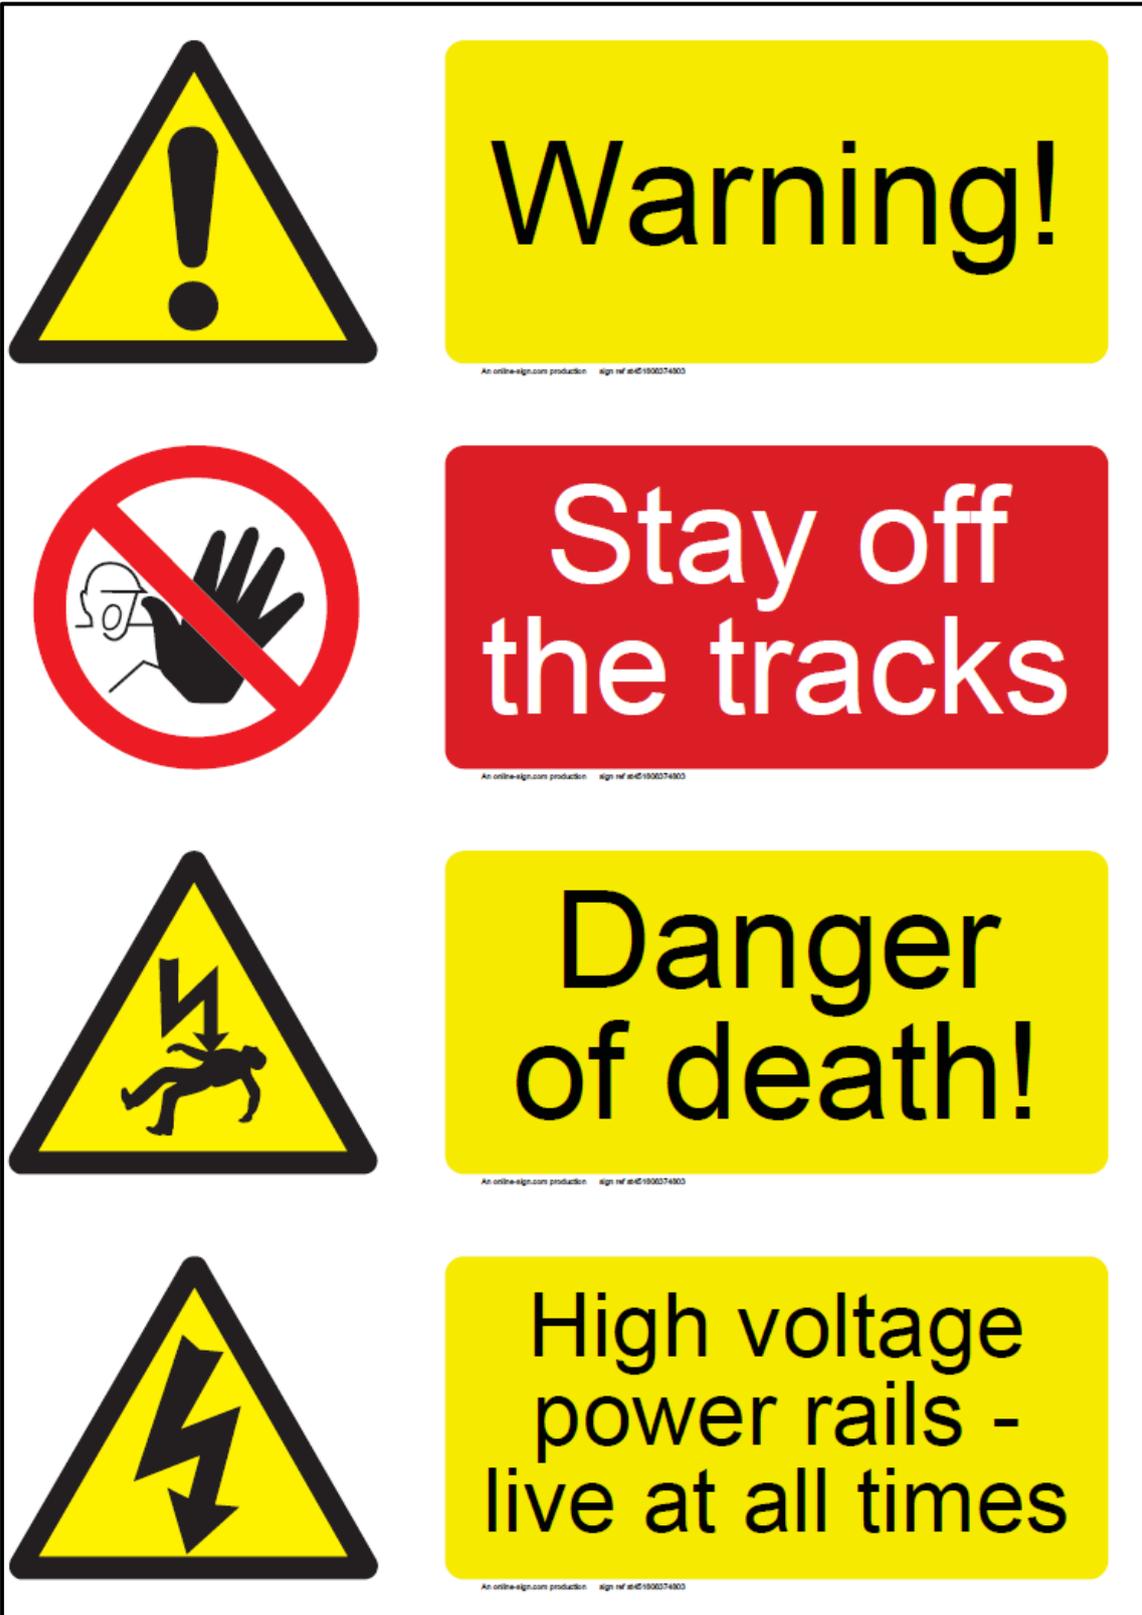
prominently the risks of the live DC conductor rails. We believe that it is these additional signs to which you refer in paragraph (1). We note your concerns regarding the use of the word “Caution” and the size of the text relating to the risk of death and have addressed these through a revised design (see Annex A).

Annex A – Initial design for new warning signs to be placed at all entrances to Canterbury East station (final design may be in landscape format).

- 11 Action (a): we will replace the three additional signs at Canterbury East station with a new design based on that shown at Annex A.

- (a) We will replace the three warning signs provided at the main entrance and palisade gates at platforms 1 and 2 at Canterbury East station with a new design as shown at Annex A. These signs reflect the concerns raised in your report and take into consideration the University of Birmingham's findings and include replacing the word "Caution" with the word "Warning" and giving greater prominence to the risk of electrocution.
- (b) We have already provided signage at the side entrance to Platform 2 at Canterbury East station which directs users to the subway at the middle of the platforms.

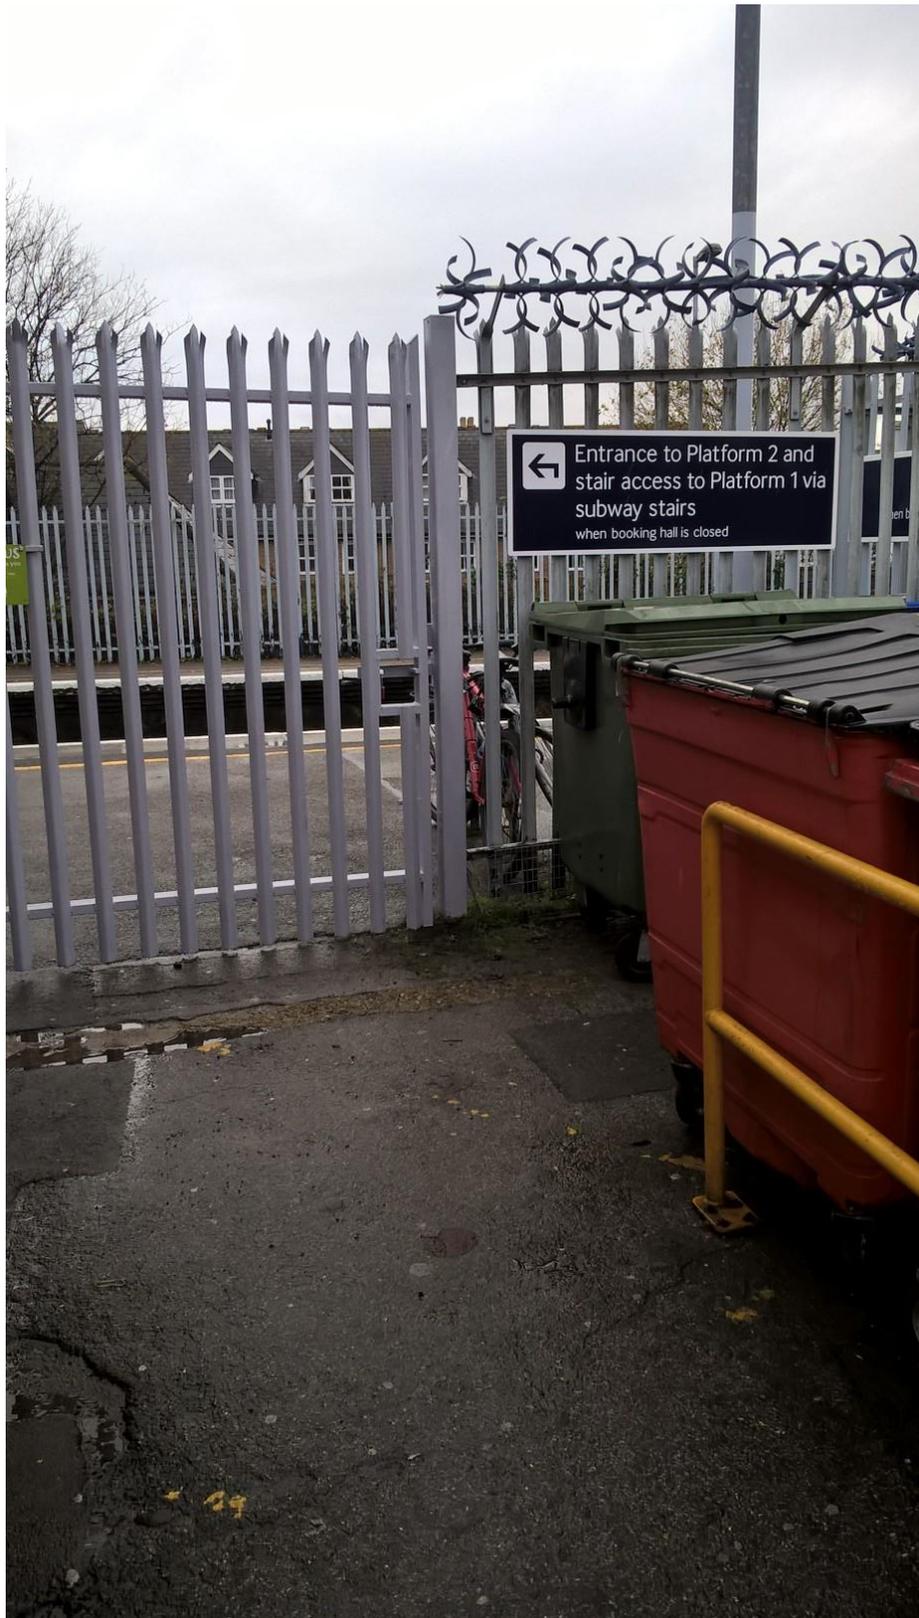
Annex B - Photograph of new sign at the side entrance to platform 2

- 17 Before the accident, directional signage to the station subway was provided in the form of a double-sided sign affixed perpendicular to the wall of the station building adjacent to the top of the subway stairs.
- 18 Following the Inquest, we have installed an additional directional sign adjacent to the entrance when entering platform 2 from the palisade gate which indicates the presence of the subway. I append a photograph of this sign *in situ* as Annex B.
- 19 Action (b) completed: A new directional sign has been installed adjacent to the side gate to platform 2.
