GRS RECOVERY WARWICKSHIRE LTD
UNITS 3 & 4 CHURCHLANDS BUSINESS PARK
UFTON ROAD, HARBURY
CV33 9GX

1. GRS Recovery Warwickshire Limited (“GRS Recovery”) provides this response in relation to the report received under Regulation 28 following the inquest touching upon the death of Holly Chevassut.

GRS Recovery response to Regulation 28

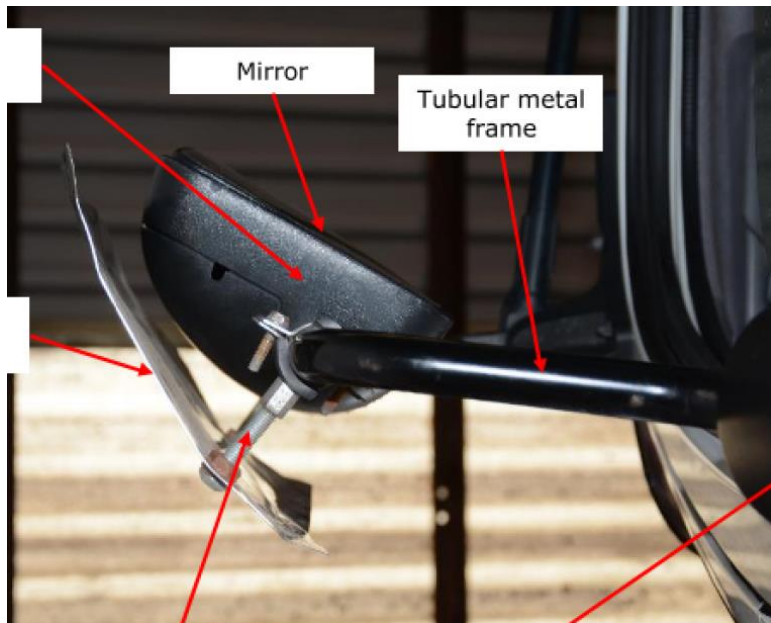
10. GRS Recovery confirm that the wing mirror protectors to Vehicle 2 have now been removed and are no longer fitted to any vehicle under 2 meters from the road surface.
11. GRS Recovery then considered a method to reduce the width of the manufacturer fitted wing-mirrors of both vehicles 1 and 2. GRS Recovery identified that the wing mirrors do not sit centrally on the tubular metal frame. Photo A below (taken from the expert report) shows a birds-eye view of the mirror housing attached to the frame as fitted by the manufacturer.
12. Due to this position, the majority of the mirror is positioned outwards of the tubular metal frame with the remainder inward between the frame and the door to the vehicle.

13. Therefore, in order to reduce the width of the wing mirrors GRS Recovery has rotated both offside and near side wing mirrors 180 degrees. This places the longer area which faced outwards from the tubular metal frame inward and vice versa. Consequently, this reduces the width of the wing mirrors. GRS Recovery provides the following examples from the offside and nearside mirrors of Vehicle 2 in Photos B and C.

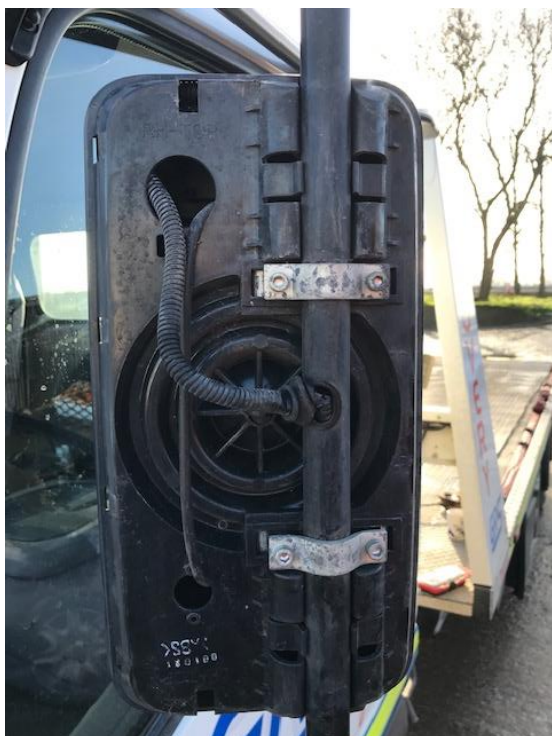
Photo B- Nearside door mirror rotated 180 degrees

14. Following the modifications, this has reduced the width of both vehicles and measurement between the widest parts of the vehicles and the wing mirror. Vehicle 1's wing mirrors project 19.25 cm from the widest part of the vehicle on each side. Vehicle 2's wing mirrors project 17cm from the widest part of the vehicle on each side.
15. Both vehicles' wing mirrors now project less than the 20cm limit prescribed by the The Road Vehicles (Construction and Use) Regulations 1986.
16. We are grateful with the Coroner for raising this issue and providing GRS Recovery the opportunity to respond. GRS Recovery will ensure that this procedure continues in future when it purchases its vehicles.

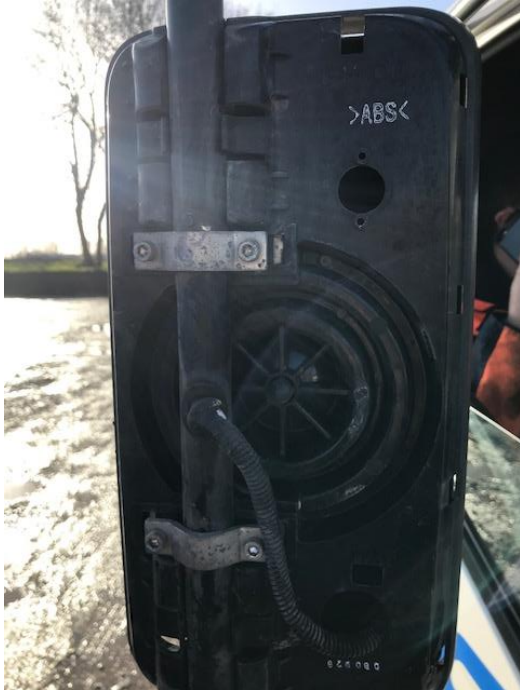
Photo C- Off side door mirror rotated 180 degrees.
