April 2019 Swallownest Osprey Ward Site Visit

Summary of Visit

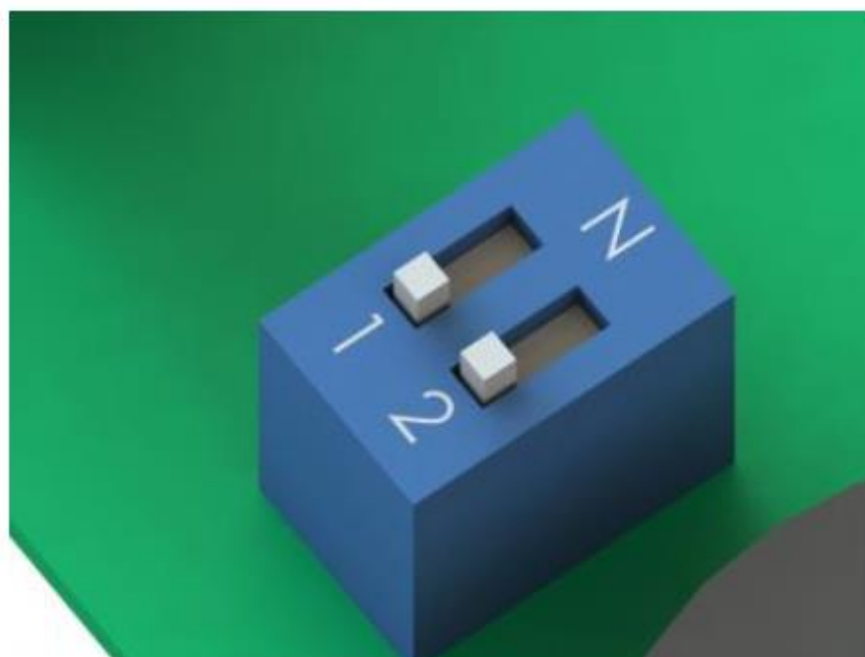
5 seconds

We then checked and recorded all of the alarms identified in the schedule as well as accessing the loft space and checking what setting the control box for room 17 was set at it was set at 5 seconds.

We tested the timing delay and it was between 5 and 6 seconds on all the alarms in the osprey ward. The timing setting on the control box in the loft space adjacent to bedroom 17 was set at 5 seconds. The operation discrepancy highlighted i.e. intermittent faults, was caused by not allowing the alarms to re-set before testing.

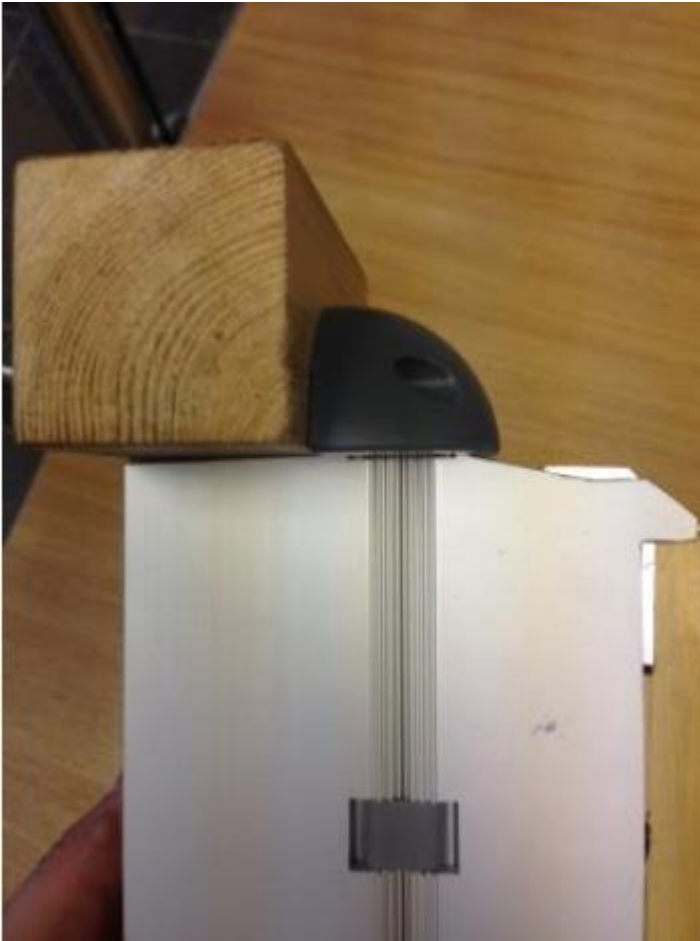
The installation of the alarm was correct, the hinge could have been slightly more elevated as per the image below and was slightly offset on the door.

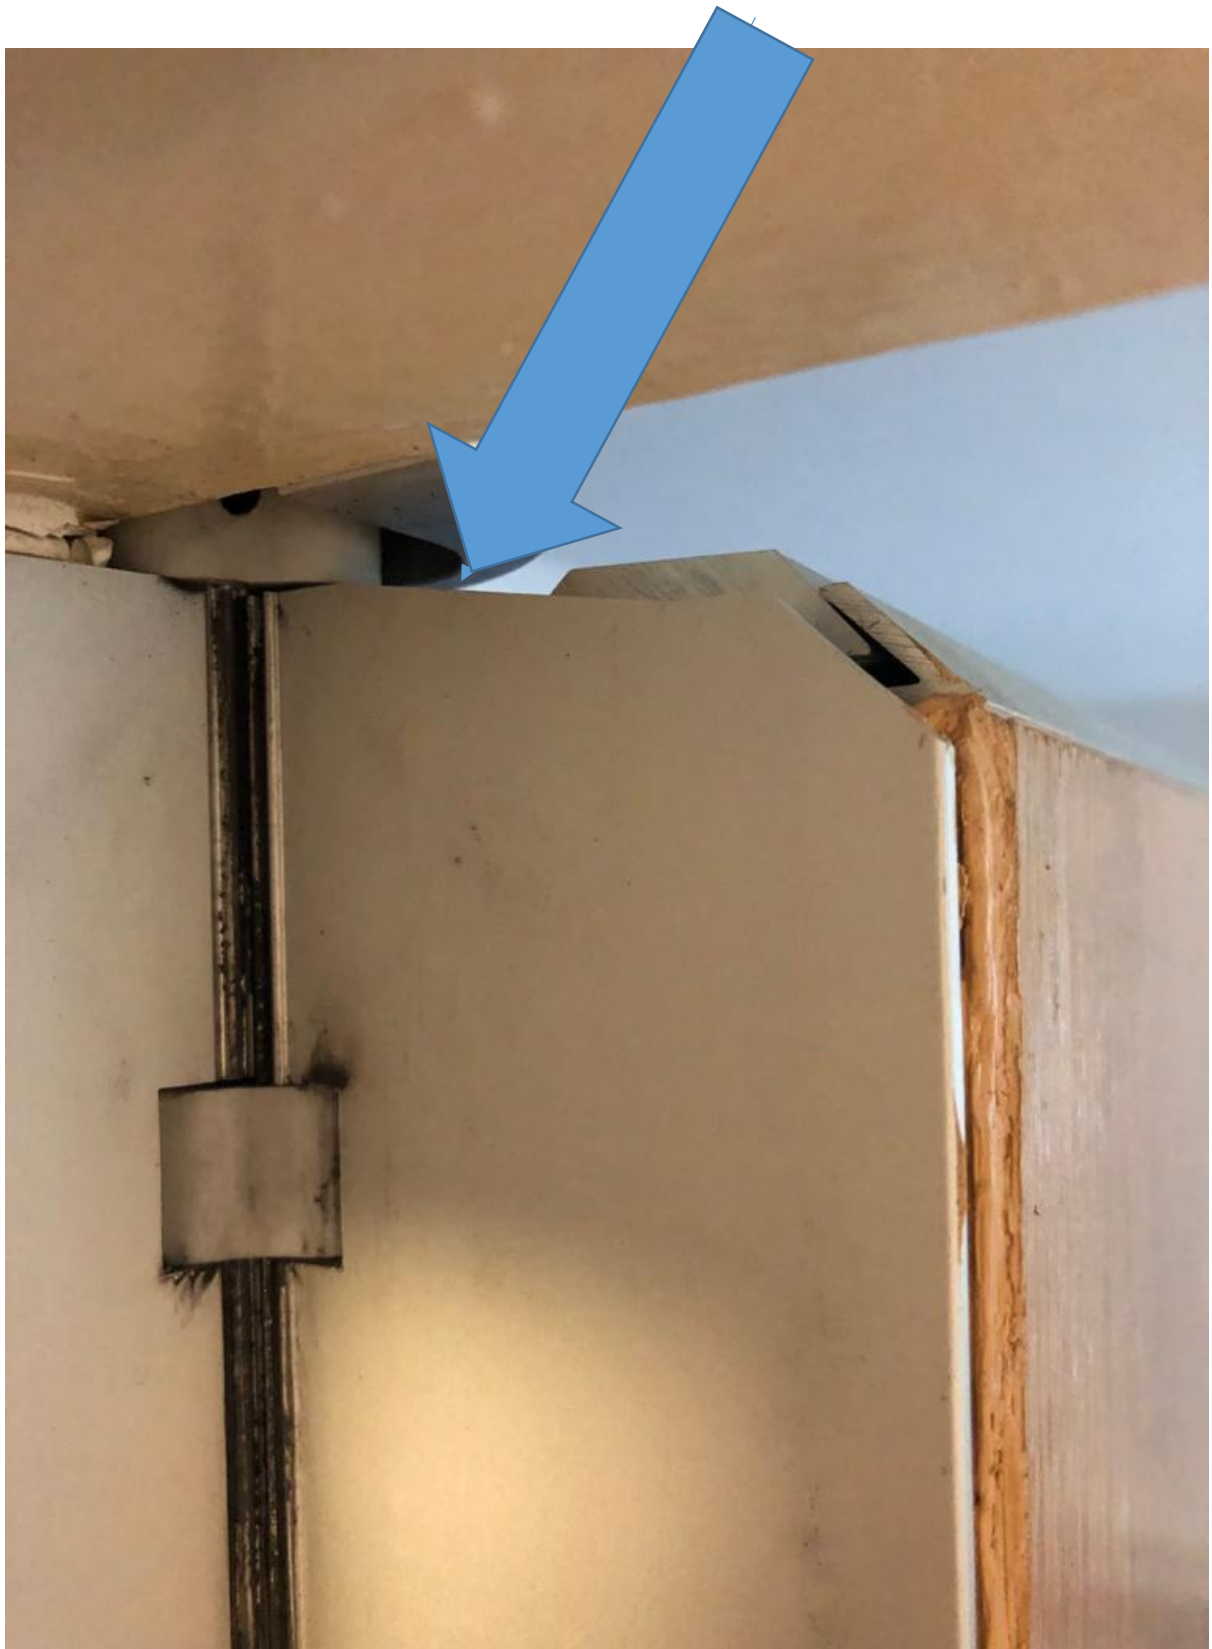
Picture 1

[REDACTED] also said he would like to organise a full PPM inspection and that the incident had occurred by forming a [REDACTED] with the patients cord out of their pyjamas between the door, frame and domed cap (see photo within appendices) this was referred to by the trust as a 'blind spot'.

The point was found to be between the door, frame and domed cap (see photo within appendices) this was referred to by the trust as a 'blind spot'

'Blind Spot'

- The alarm design was immediately amended to include a mechanical fixing between the hinge and the alarm so as to reduce the risk of [REDACTED] further. All NHS trusts have made aware of the re-designed door alarm that is available.
