17 August 2022

## Regulation 28 Report to Prevent Future Death – Death of Connor Peter Marron

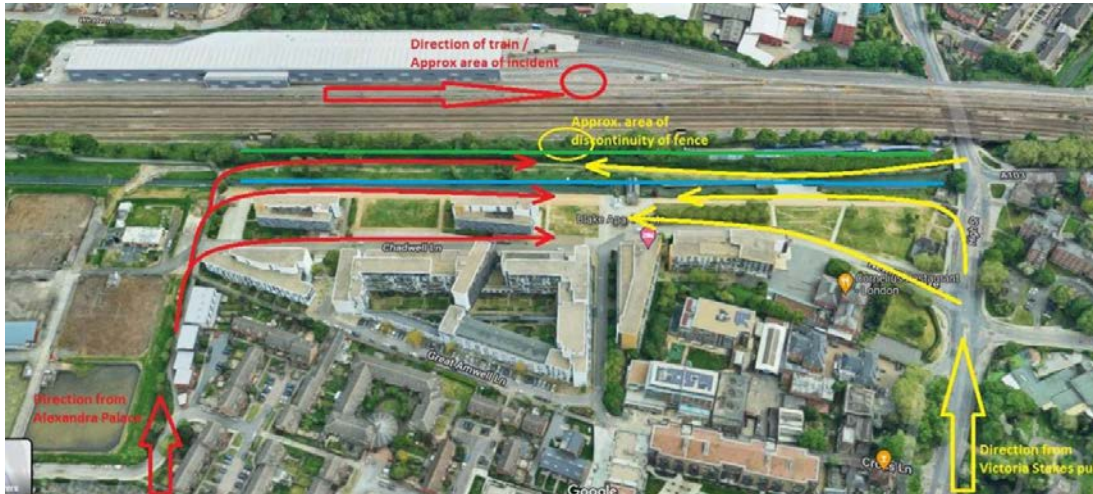
Picture 1 – BTP Post Incident Site Report

We understand that the Inquest did not conclude whether Mr Marron accessed the New River or at what location. Therefore, our investigations focussed on a specific stretch of the New River as detailed in the “British Transport Police – Post Incident Site Report” and highlighted in Picture 1 below. This response sets out what signage and lighting is currently in place in that area and where we anticipate we will undertake further assessment or make changes.

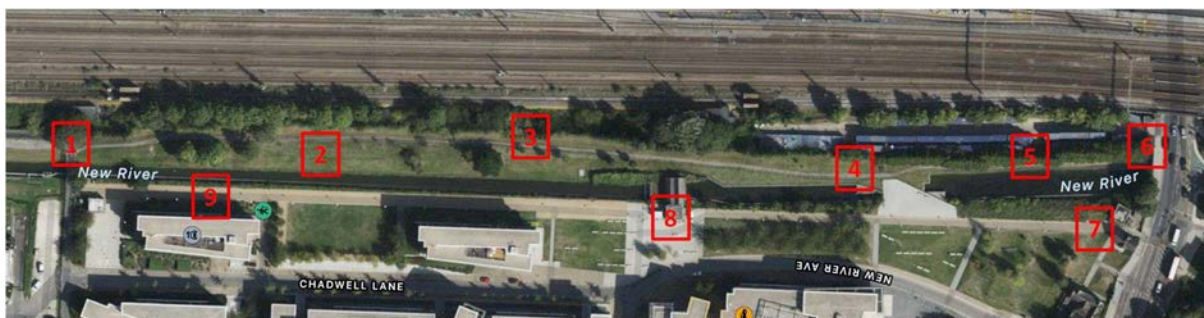
Picture 2 – Observation points from inspection

Observations of the specific area of river shown in Picture 1, relate to 9 locations show in Picture 2 below. In the interest of brevity, I reference the location and observation.

Below is a summary of the observations made by the Health & Safety team during their site visit. It should be noted that locations 1 to 6 constitute Thames Water property, locations 7 to 9 are private property belonging to the developer of apartments along Chadwell Lane and New River Avenue.

Location 1 has a kissing gate entrance to the New River path, with palisade fencing on either side in good condition. There is a small notice on the gate concerning right of access and entry at one's own risk. However, the Thames Water standard hazard warning sign stating, 'danger deep water, no swimming, no boating, no fishing', which should be displayed at each access point to the river is not in place in this location. Arrangements have been made for this to be installed so it will mirror the signage at location 6 (see further comments below).

At location 2, the riverbank from Chadwell Lane is overgrown and the sheet piled vertical bank would make entry difficult and likely result in total immersion. Similarly, to gain access across the river, in situ pipework would need to be traversed, again making this difficult and almost certainly result in total immersion.

The pathway at location 1 is a significant distance from the bank of the river, making accidental entry unlikely at this point. The river depth between location 1 and the sluice at location 8 is around 130cm to 140cm, with a further 30cm to 40cm of silt on the riverbed. So, access along this stretch from either bank could be inconsistent with being wet from the waist down given the total depth of 160cm to 180cm, possibly slightly higher during the winter flow.

We understand that location 3 is the point at which Mr Marron is believed to have passed through the Network Rail fence onto the train track. At this location the path is a significant distance from the river and the location where the hole in the fence was found is obscured by trees.

There is no lighting between location 1 & 4, however the development on Chadwell Lane provides 'borrowed' lighting from streetlights and the apartments themselves (also see comments below)

Location 4 consists of a concrete viewing area covering a channelled section of river. This is accessed from the Chadwell Lane development and is fully fenced, although it appears possible to pass between the fence railing to use this viewing area to traverse the river. There is dense undergrowth on the Chadwell Lane bank and shear sides of the channel. At this point the area is lit from the Chadwell Lane side.

The river path at location 5 is at its narrowest, being close to the river, separated by a narrow steep bank, which shows some damage. There are also tree branches extending over the path close to head height. The path has no lighting but has borrowed lighting from the streetlights on the Chadwell Lane development and the High Street. At location 5 the river is 60cm – 70cm deep with around 20 cm of silt. On the opposite bank a brick pumping house is visible, with significant graffiti and direct access to the river.

Location 6 has a kissing gate entrance to the New River path accessed from the High Street. Thames Water standard hazard warning sign (stating 'danger deep water, no swimming, no boating, no fishing') is in place.

Location 7 is the entry point to the development on New River Avenue and Chadwell Lane and is private property. There are Danger Deep Water signs in place along the length of the development pathway along the bank of the New River.

It was also noted that along the side of a brick pump house there appeared to be a well-used path, indicating frequent access. To the rear of the pump house is a water discharge point that gives direct access into the New River.

At this location the river depth is 60cm to 70cm with very little or no silt on the riverbed. It is also noted that at location 7 the in situ pipe running in the river ceases, so this is the only location on the development side of the river where a crossing could be made, unobstructed.

At location 8, there is a sluice and sluice building, traversing the river. The building is secure with fenced access along one side. The nearside bank (Chadwell Lane) is fenced as is the far side with Palisade fencing. To one side of the sluice is a pipe crossing, here the pipe is protected with anti-climb measures and again fencing exists on both sides. It is therefore unlikely that access could be gained to the river or crossing possible due to the palisade fencing.

Location 9 is on the path by the New River at the development on Chadwell Lane. There is ample street lighting as well as a double chain link fence and 'danger deep water' signage.

Having visited and reviewed these locations in detail, there is warning signage pertaining to water hazards in place both on Thames Water property and the Chadwell Lane development, however location 1 requires signage to be installed. Although not something in the control of Thames Water, the owner of the Chadwell Lane development may wish to review signage at location 7. Signage relating to the railway along its fence line is for Network Rail to make comments/recommendation.

There appears to be adequate lighting on the Chadwell Lane development. The absence of lighting on Thames Water property would make visibility at night on the New River Path low, but not completely dark due to the borrowed light from the opposite bank and surrounding urban area. The river itself reflects light and would be distinguishable from the path even in overcast weather at night. This coupled with the general distance of the path from the river, presents a low risk for a majority of the area concerned. Where the path narrows at location 5 and there are overhanging trees, where we will undertake a further review and make any necessary changes.

Fencing of the river to prevent access, is present on the Chadwell Lane development, except for location 7, where there is also evidence of regular use (trodden path, graffiti etc.) of the area behind the pump building allowing for access directly into the river. Our assessment found that fencing on the Thames Water bank

1. Install New River Path warning signage adjacent to the kissing gate in location 1 by the end of September 2022.
2. Remove overhanging branches at location 5 by the end of September 2022.

3. Investigate options to improve the path and bank at its narrowest point, including considering lighting levels at location 5 by the end of December 2002. Implementing any recommendation as soon as possible subject to necessary consents.

4. Write to Property Owner of the Chadwell Lane development by the end of September to share the outcome of the assessment we have undertaken with respect to access controls and signage at location 7.
