CONTINUOUS ASSETS

C02758 – M20 J6 to J5 Drainage

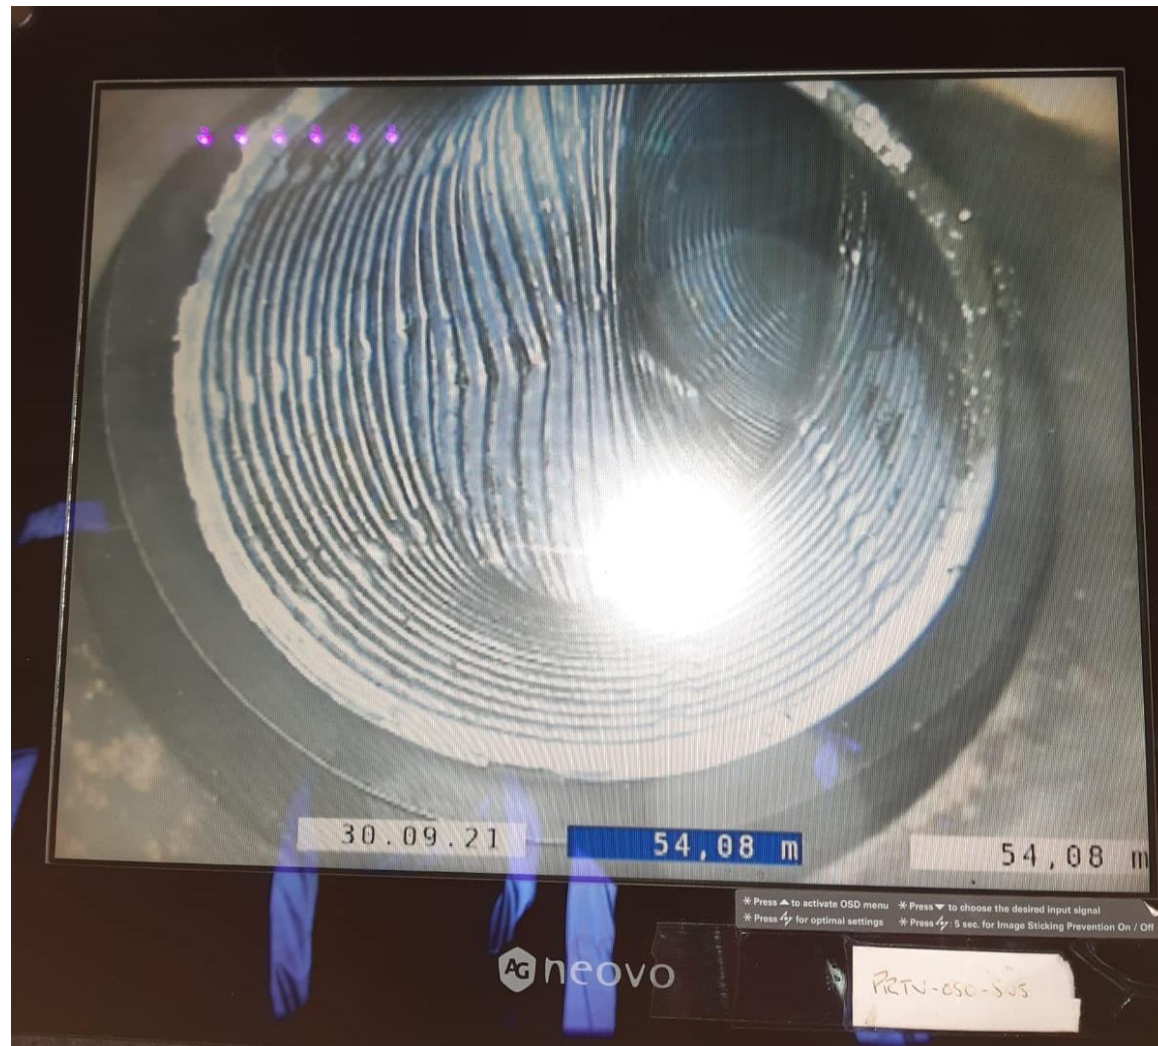
Deformed lateral connection above MH4009 to MH4010 pipe

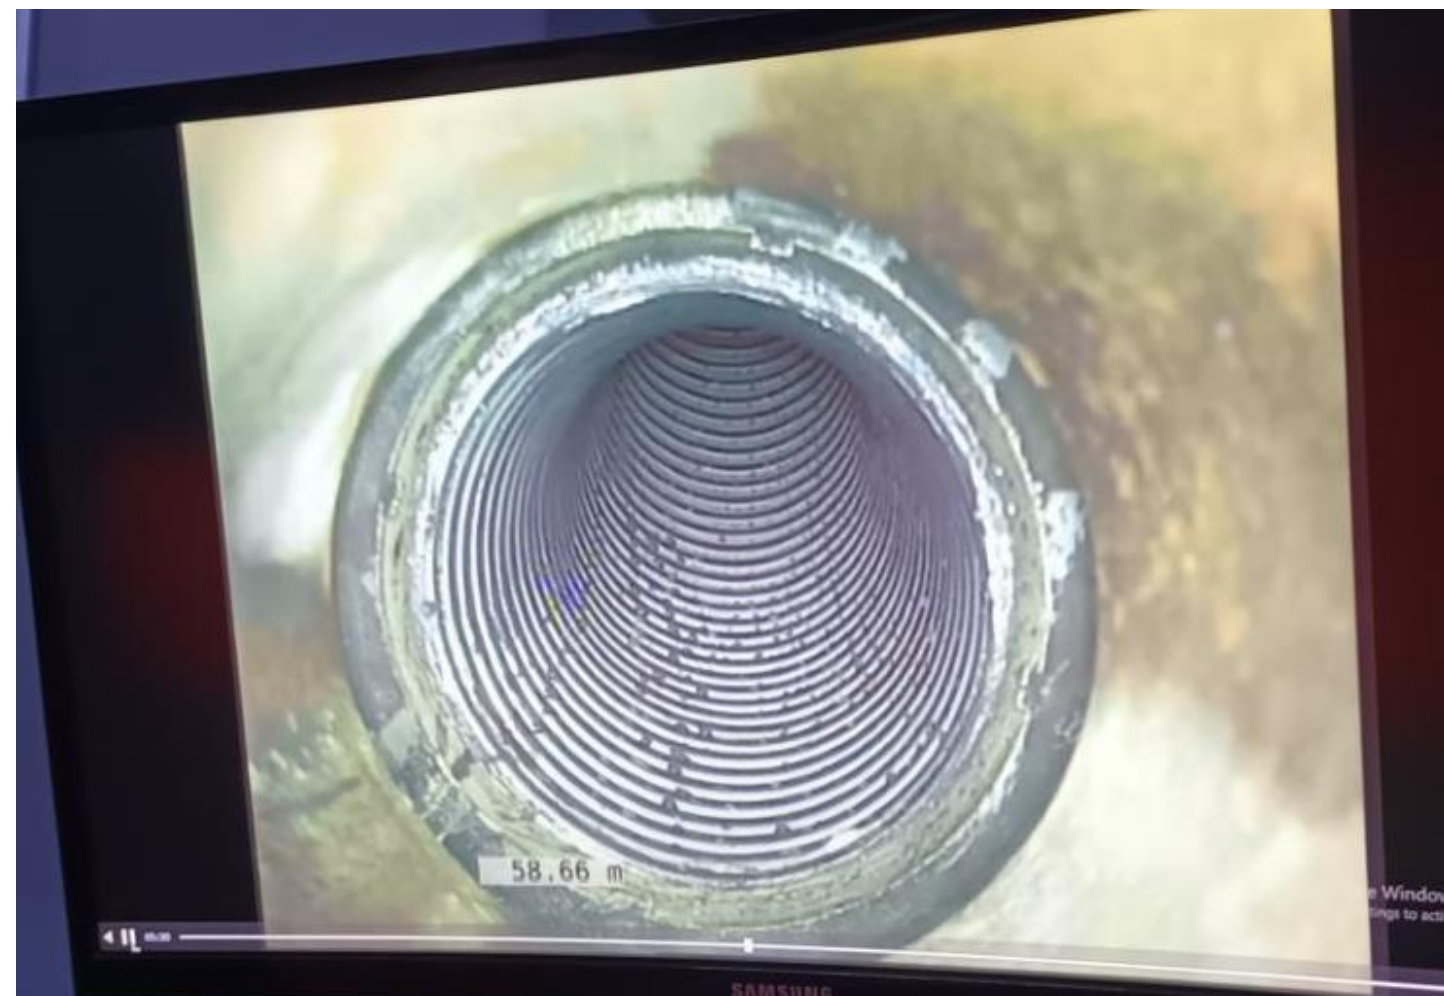
Post Repair CCTV footage of connection
