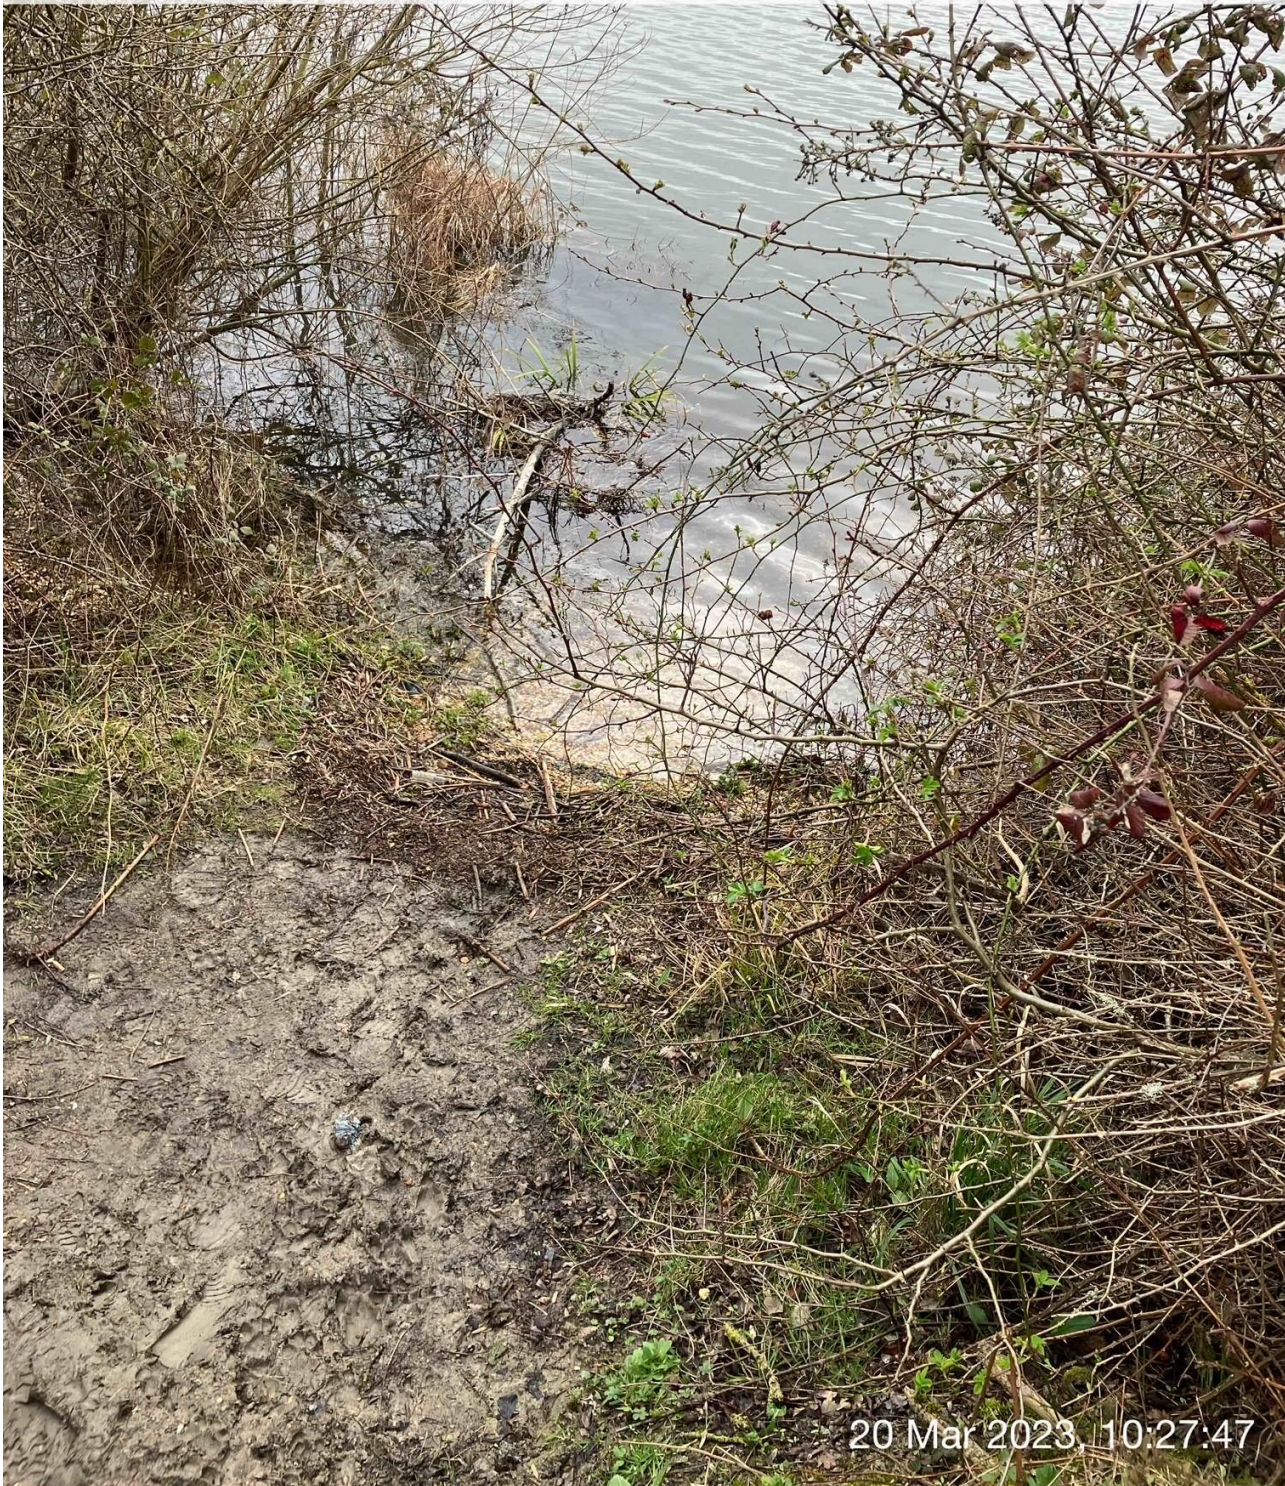
Gullwatch - Other

The Trust has looked at installing additional unlocked throw lines in areas where there are secure lines in place. It has also considered whether these can be located closer to the edge of the lake. The locked lines are on the main lakeside walkway where they are most visible to members of the public. As has been highlighted in evidence and previous written submissions, the water level of the lake varies significantly throughout the year as the lake is part of the flood defences in the area. We have described the role of the IDB in response to point 3 above. To illustrate the impact of this on the shoreline we attach two photographs taken in March 2023 showing the general area where this incident occurred. It can be seen that the area where the children were playing is completely under water.

Whilst it is not accepted the secure throw lines were "very far away" from the water, in order to deal with HM Senior Coroner's concern on this issue the Trust will install additional unlocked lines closer to the high water mark of the lake at locations 5 and 7, and at the other points around the lake and closer to the edge of the lake in locations where there have been previous incidents of swimming.
