Response to Regulation 28 Report to Prevent Future Deaths, on behalf of the Trustees of the Ymddiriedolaeth Clough Williams-Ellis Foundation.

Agents to the Trustees of the Ymddiriedolaeth Clough Williams-Ellis Foundation

February 2024

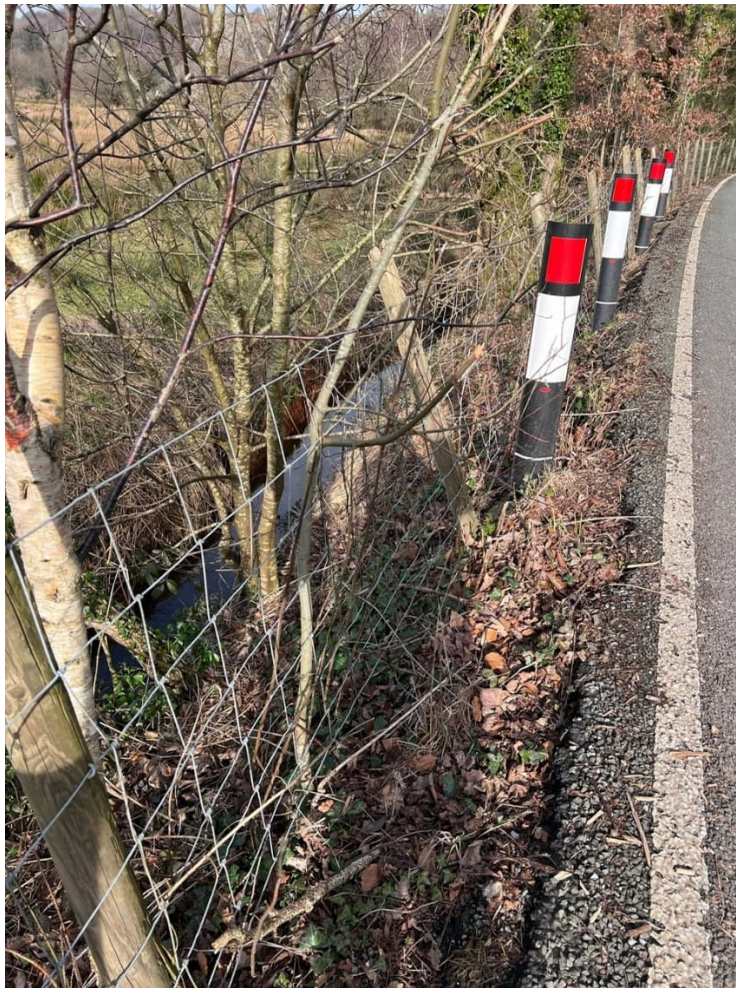
- 3.2 In any case stock fencing is not meant to be a feature of highway safety and is not designed to withstand the force of a car hitting it at speed, and if that was its intended purpose something more robust ought to have been considered.

3.5 The below photograph shows the section of stock fencing erected by Cyngor Gwynedd behind bollards recently erected by Cyngor Gwynedd.

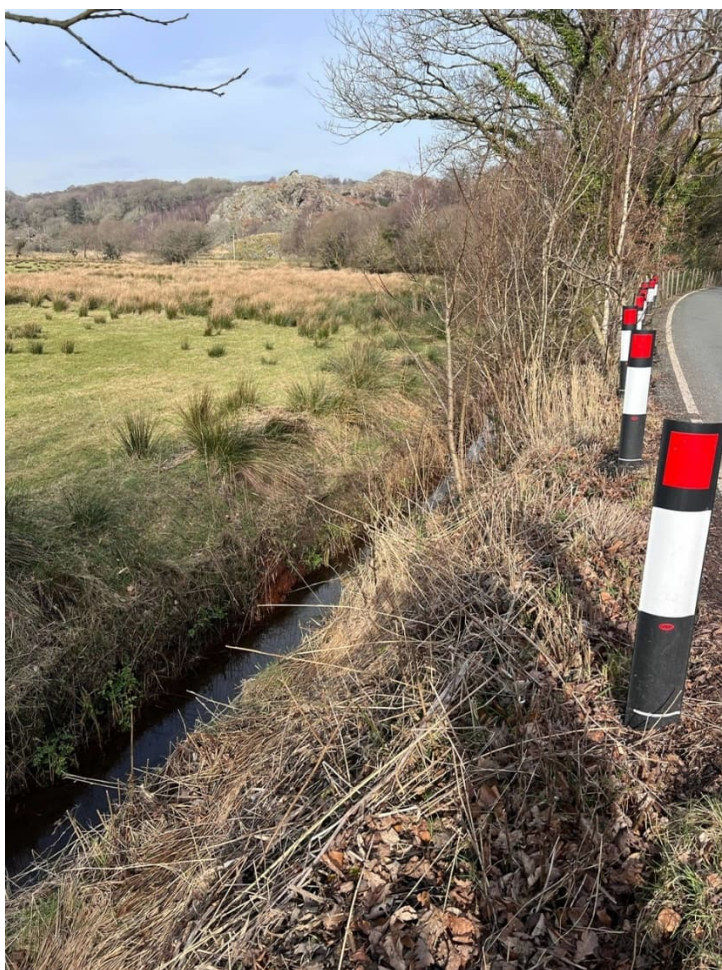
3.5 The below photograph shows the point where the car entered the ditch, where no stock fencing exists or existed, but now has the bollards installed by Cyngor Gwynedd.

3.6 The bollards, whilst delineating the edge of the carriageway, are of low quality and unlikely to be sufficiently strong to prevent a vehicle crashing through them and potentially ending up in the ditch below.
