Regulation 28 Notice - Kirklees Council Response

Inquest into the Death of Danielle Lea Broadhead

Report to Prevent Further Deaths

Kirklees Council response

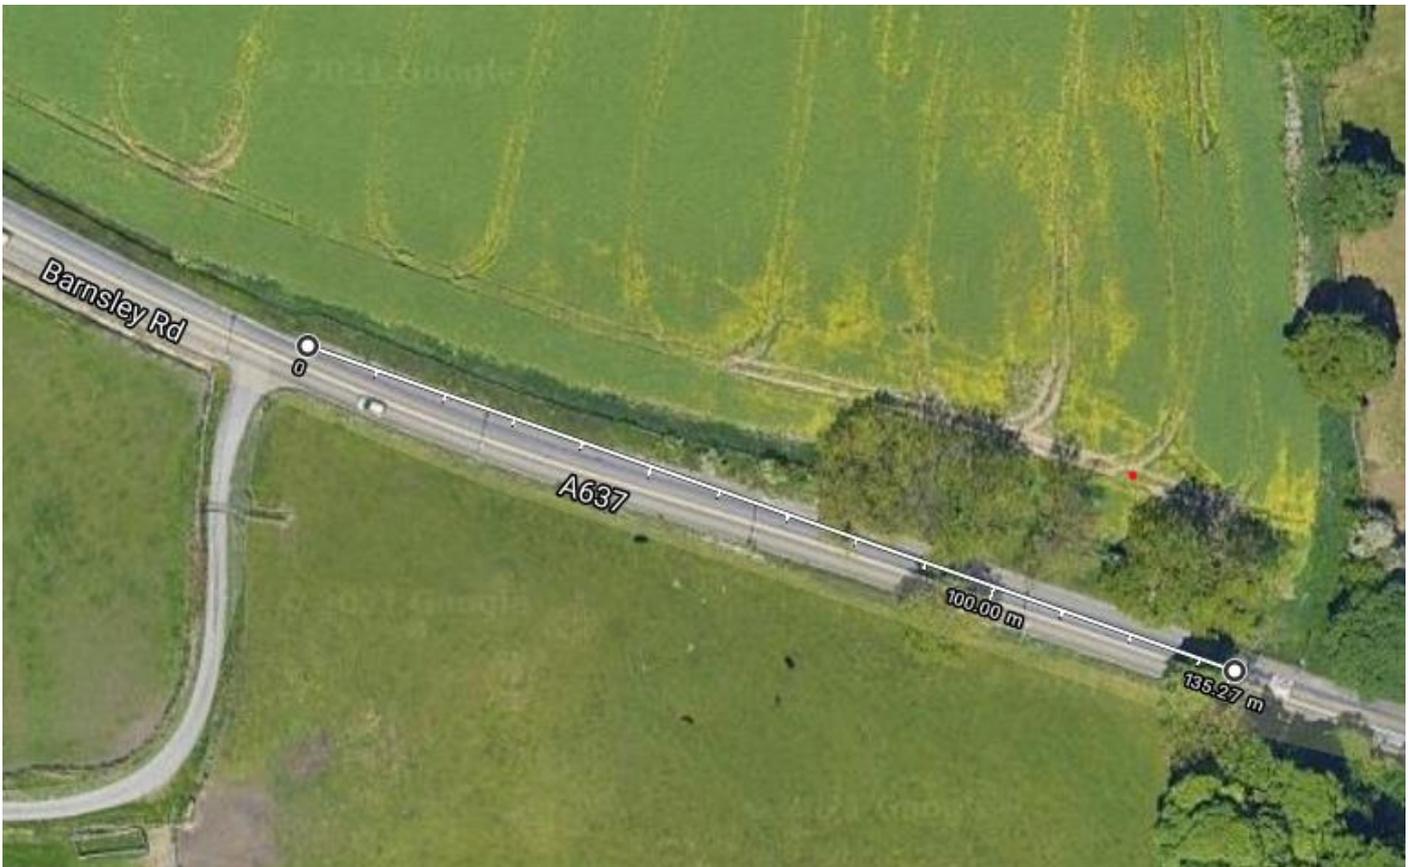
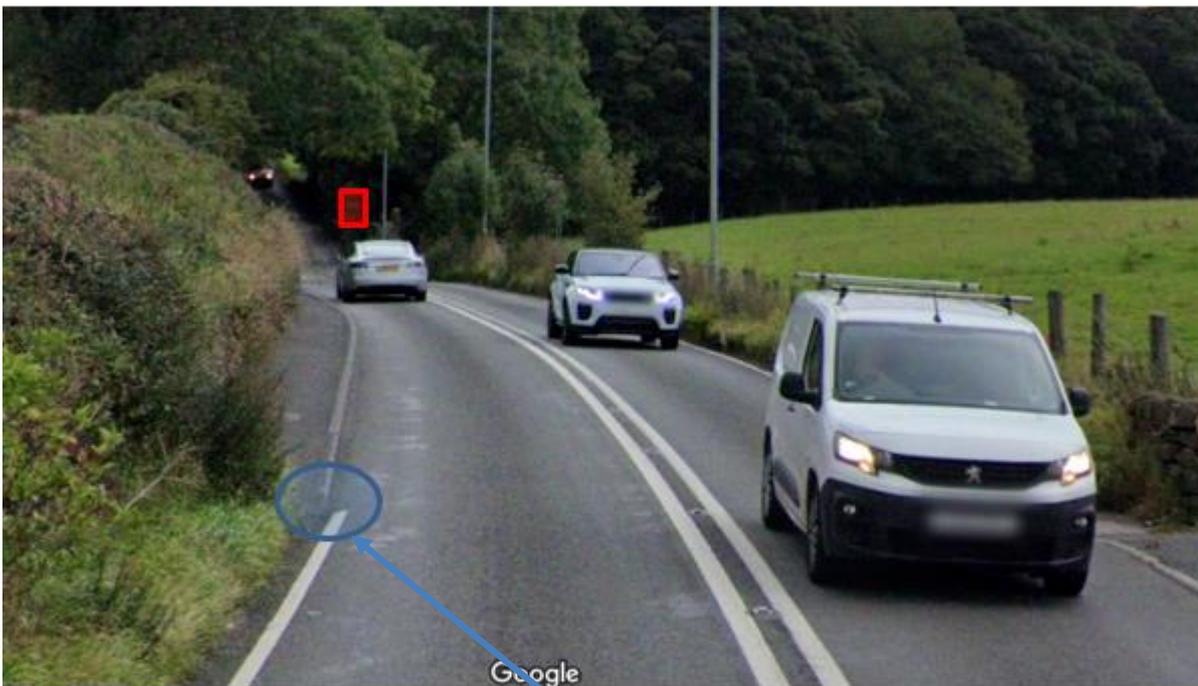
They identified, on site, the kerb in question as one some 135m west of the site of the collision, and there was no evidence on site, at the time of the visit, or since, that this kerb has frequently been struck by vehicles.

The location of the kerb, where there is a change from grassed verge to made footway, is approximately 500m to the West of the junction of Haigh Lane opposite a private drive entrance. At the point of the change there is an existing edge of carriageway line leading drivers away from where the kerbing starts. This line was last re-instated in 2016 as part of the road surface dressing works. The google image above was captured in Sept 2020.

The centre lane is made up of a double white line system (also reinstated in 2016) both have been installed in accordance with "Traffic Signs Regulations and General Directions 2016" and associated "TSM Chapter 5 – Road Markings"

The change from verge to footway is made by transition kerbs, into full height kerb, with the verge and made tarmac footway being same width.

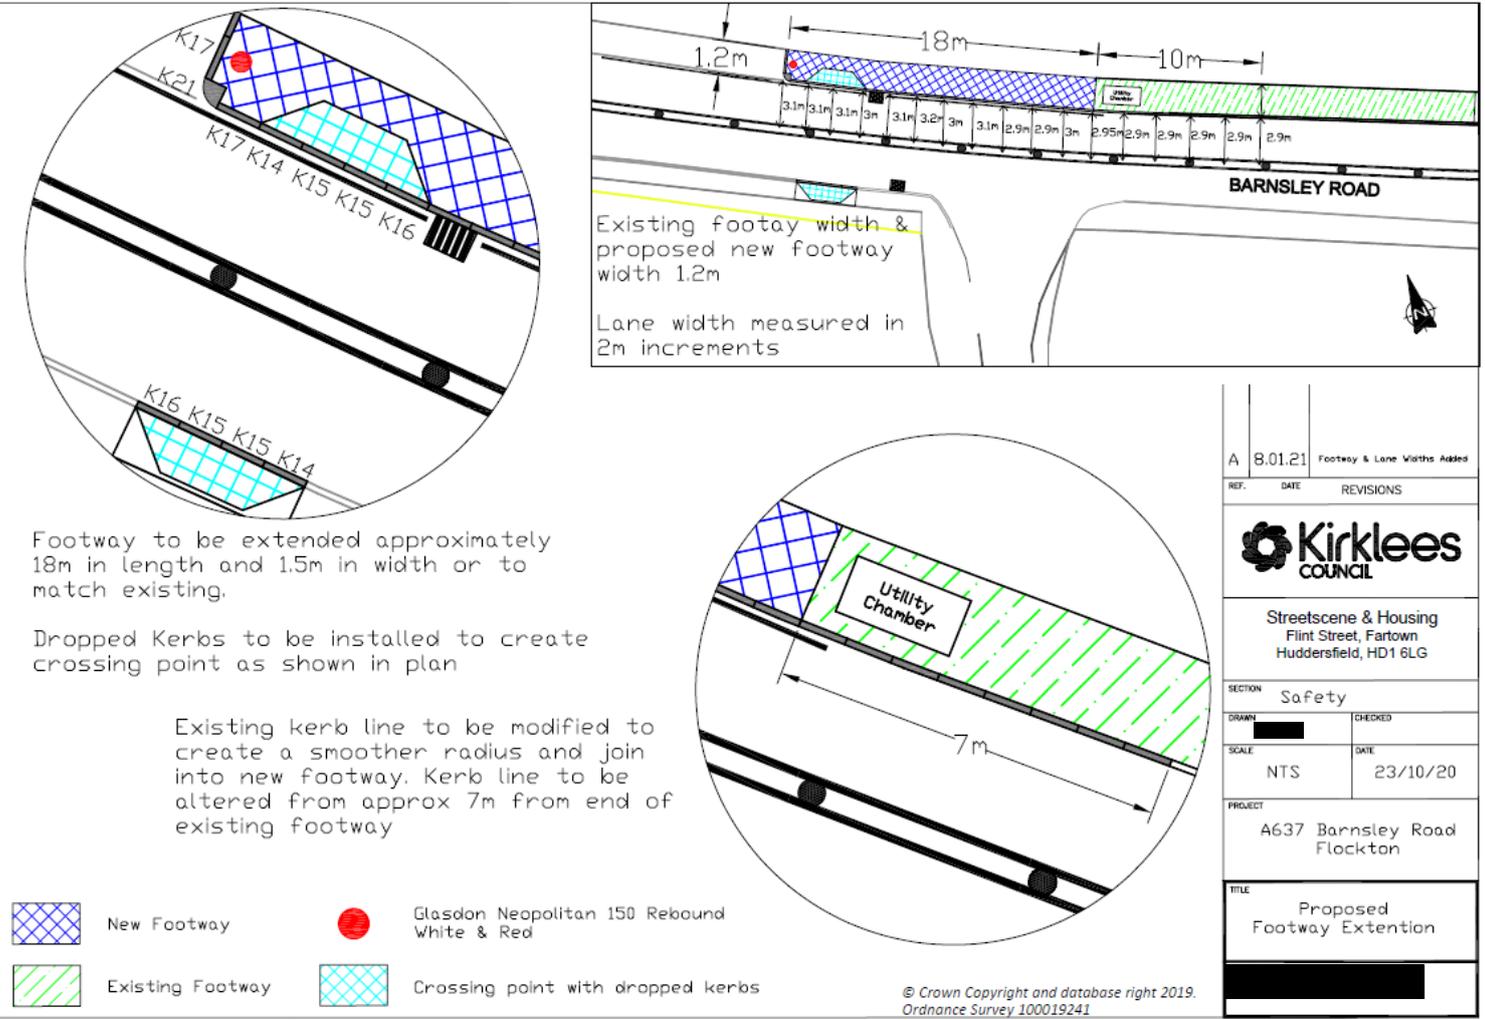
The result of those investigations was, to improve the opportunity for pedestrians to cross Barnsley Road at this point, where the footpath stops on the northside and continues on the south, a scheme would be developed that extended the northern footway some 18m. This then extends this footway to overlap the footway provided on the southern side of Barnsley Rd allowing pedestrians to cross at 90^o to the road, rather than the current angle and improves forward visibility for both pedestrians and drivers alike, of each other.

These proposals (shown on the diagram below) have been subject to the required Road Safety Audit process, and no concerns regarding the scheme and its detail design have been raised.

The footway maintenance scheme started, working from Grange Moor roundabout, to Flockton village, on the 7th May 2021, and is programmed for 6 – 8 weeks, weather permitting. The works proposed below are to be carried out as part of these works.
