RESPONSE TO REGULATION 28: REPORT TO PREVENT FUTURE DEATHS (1)

Vehicle involved in incident and assistance provided to Police

Report to prevent future deaths

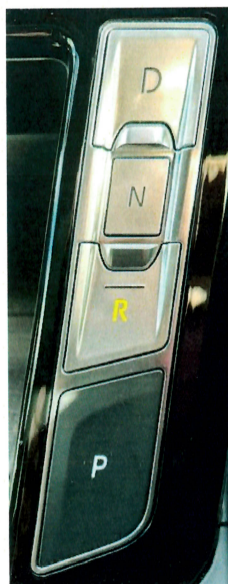
Figure 1- Photo of Jaguar I-Pace gear transmission control unit with reverse selected

This gear transmission control unit is located in the centre console and measures 14.405 cm.

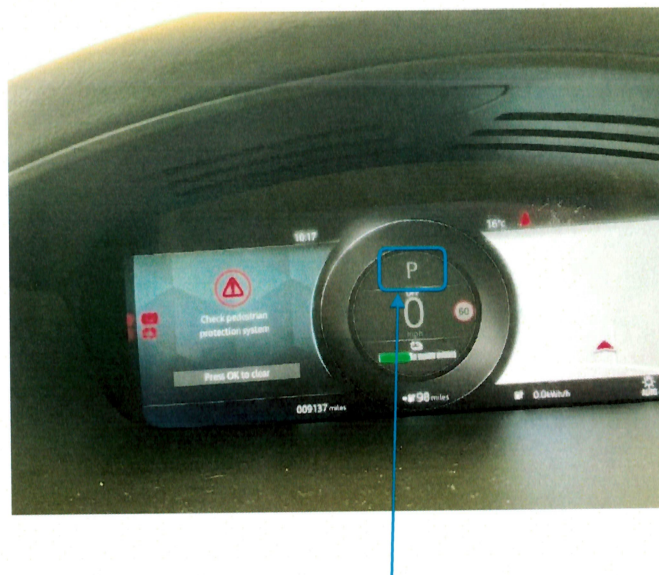
A visual indication on the instrument cluster to indicate the gear selected, i.e. R showing on the instrument cluster when reverse gear is selected, is also provided to the driver.

Figure 3 - Image of the instrument cluster of [REDACTED] with Park selected taken on 2nd May 2023 during the vehicle inspection

- The visual indicator in the instrument cluster would have displayed 'R';
- The rear camera would have engaged on the 10.25 inch LCD infotainment touchscreen;
- The R gear selector button would have illuminated; and
- The auditory warning would have sounded.

The visual indicator on the instrument cluster is in the clear line of sight of the driver. The visual change on the infotainment touchscreen is a clear and obvious indication that you have selected reverse, and the auditory warning can be heard. However, none of these features would have been engaged or showing R at the time of the incident, as reverse had not been selected. The D gear selector would have been illuminated and the visual indicator in the instrument cluster would have displayed "D".

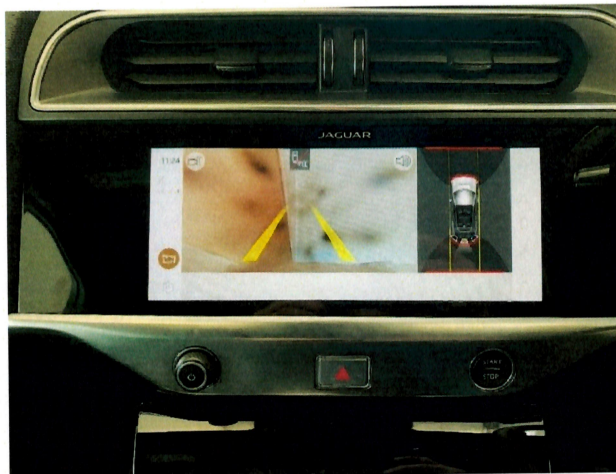
Also, when R is engaged, the rear facing image and 360 degree surround view appears on the infotainment touchscreen (as shown below) which is clearly visible on the centre console above the gear transmission control unit. The infotainment touchscreen is a 10.25 inch LCD display with a resolution of 1920x720 and an aspect ratio of 8:3.

Figure 4 - Image of the infotainment touchscreen of [REDACTED] taken on 2nd May 2023 during the vehicle inspection with reverse selected
