CONTINUOUS ASSETS

C02758 – M20 J6 to J5 Drainage

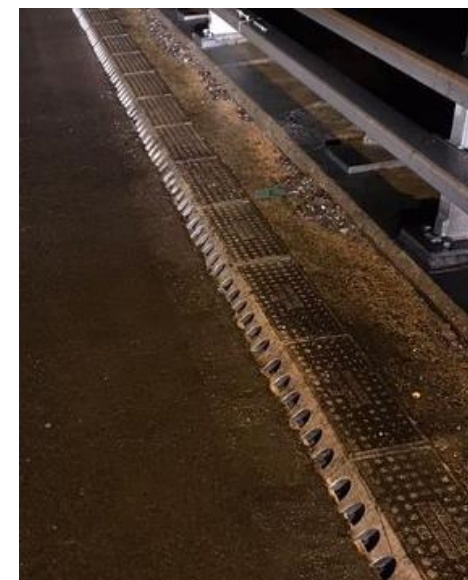
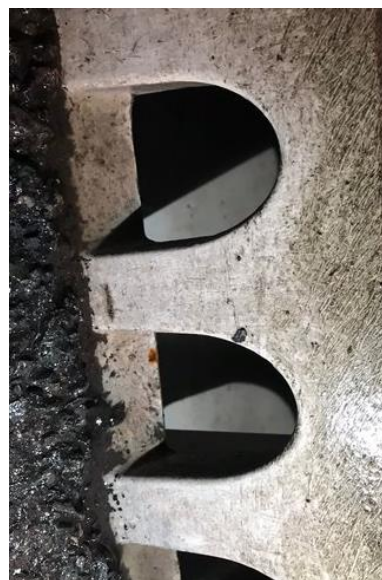
Cleansed the Combined Kerb Drainage Units (CDKU's) along the central reserve at the Medway River and railway crossings including Removal of detritus build up in front of the inlet apertures.

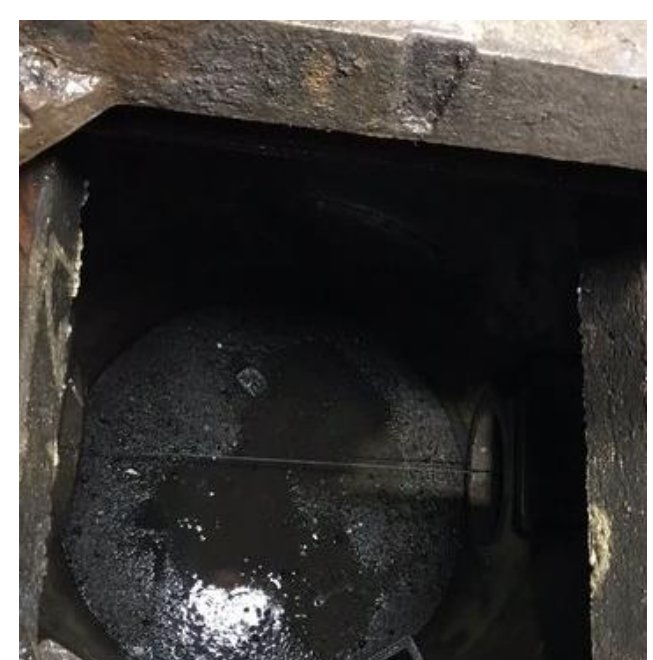
Cleansed Catch pits in Central Reserve between VRS lines and although not part of original scope also cleansed 150 linear metres of wide concrete channel between the VRS lines.
